DEPARTMENT OF TRANSPORTATION

Quality Assurance and Source Inspection

Contract #: 04-0120F4Cty: SF/ALA Rte: 80 PM: 13.2/13.9File #: 1.28**WELDING INSPECTION REPORT****Resident Engineer:** Casey, William**Address:** 333 Burma Road**City:** Oakland, CA 94607**Report No:** WIR-028397**Date Inspected:** 14-Sep-2012**Project Name:** SAS Superstructure**OSM Arrival Time:** 700**Prime Contractor:** American Bridge/Fluor Enterprises, a JV**OSM Departure Time:** 1930**Contractor:** American Bridge/Fluor Enterprises, a JV**Location:** S.A.S. Job site**CWI Name:** N / A**CWI Present:** Yes No**Inspected CWI report:** Yes No N/A**Rod Oven in Use:** Yes No N/A**Electrode to specification:** Yes No N/A**Weld Procedures Followed:** Yes No N/A**Qualified Welders:** Yes No N/A**Verified Joint Fit-up:** Yes No N/A**Approved Drawings:** Yes No N/A**Approved WPS:** Yes No N/A**Delayed / Cancelled:** Yes No N/A**Bridge No:** 34-0006**Component:** S.A.S. Structure**Summary of Items Observed:**

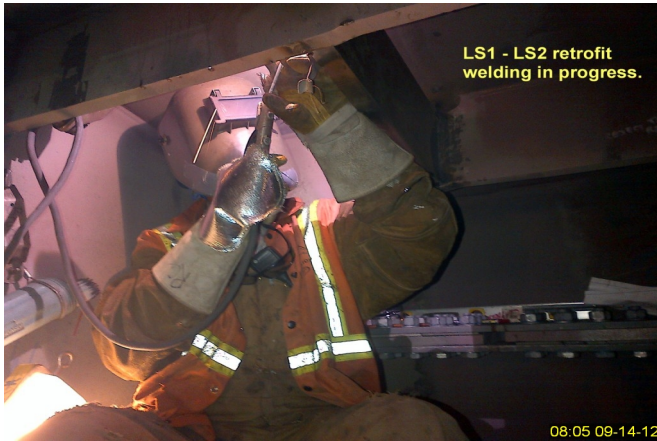
The QAI was tasked with monitoring the welding and repairs being performed by ABF welder Rick Clayborn, ID 2773. The QAI noted that retrofit of longitudinal stiffeners (LS) is continuing in OBG 12W at panel point (pp) 111.1, adjacent to the corner assembly splice welds. The QAI observed welding of the retrofit plate between LS1 and LS2. The QAI noted that the welding is being monitored by the Quality Control Inspector (QCI) Pat Swain. The QAI noted that there are 2 vertical fillet welds (3F) remaining to be made at this location. The QAI noted that welding procedure specification (WPS) ABF-WPS-D15-F1200A is being utilized with an elevated preheat temperature due to the LS being grade 485W. The QAI noted that during the welding, the preheat and interpass temperatures were maintained and the welding parameters were within the ranges listed on the WPS. Upon completion of the welding, the QAI noted that the welds appeared to be visually conforming to the contract requirements but the final inspection will not be completed until the required cooling time is achieved. Reference the attached photo.

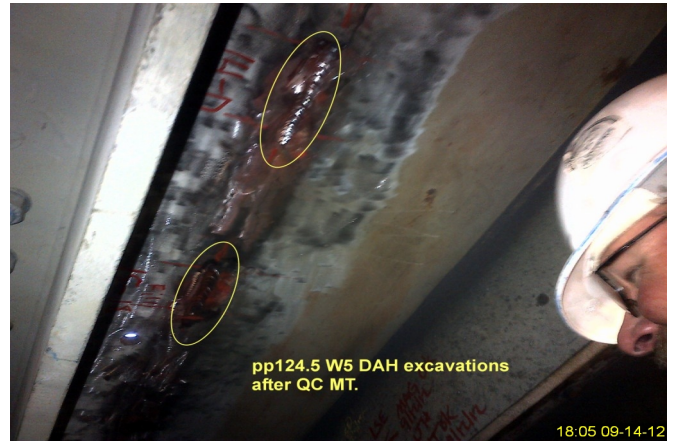
The QAI was informed that repairs of Deck Access Hole (DAH) LS-West, at pp124.5, line W5, will be repaired. The QAI observed the excavation of the weld to be 95mm long, 20mm deep and 30mm wide. The QAI noted that the excavation was examined using Magnetic Particle Testing (MT) by the QCI Pat Swain. The QAI was informed that the vertical groove (3G) complete joint penetration (CJP) repair is in grade 485W steel and will utilize ABF-WPS-D15-1002-Repair. The QAI observed that during the welding, the preheat and interpass temperatures were maintained and the welding parameters were within the ranges listed on the WPS. The QAI

Upon completion of the LS-West repair, the welder went back to 12W, pp111.1 and fit up the remaining retrofit plate between LS-2 and LS-3. The QAI was informed that the welding will not be performed during this shift. The QAI was informed that the DAH weld at pp124.5 W5 will begin repairs. The QAI noted that this weld is designated as SPCM. The QAI witnessed the excavation of 3 portions of the DAH weld that have been identified by QCI examination as rejectable. The repair locations are Y=125mm, Y=1685mm and Y=4150mm. The QAI noted that the lengths of rejected weld and the depth of the weld excavations do not require a critical weld repair at this time. Upon completion of the excavations, the depth and length of the excavations are: Y=125:18mm W:10mm D:115mm L; Y=1685: 18mm W: 10mm D: 110mm L; Y=4150: 35mm W: 10mm D: 140mm L. The QAI noted that all 3 off these excavations were made from the bottom (face B) of the DAH weld. The QAI noted that the excavations were examined with MT by the QCI Pat Swain. The QAI also noted that the weld was preheated to 225F prior to carbon arc gouging the excavations. Upon completion of this work, the QAI was informed that there isn't enough time remaining in the work shift to perform the weld repairs and no additional work will be performed. See the attached photo.
